**REC-ERC-89-4**

# **INVESTIGATION OF ALKALI-SILICA REACTIVITY IN FOUR DAMS IN THE SOUTHEASTERN UNITED STATES**

**July 1989**

**U. S. Department of the Interior  
Bureau of Reclamation**

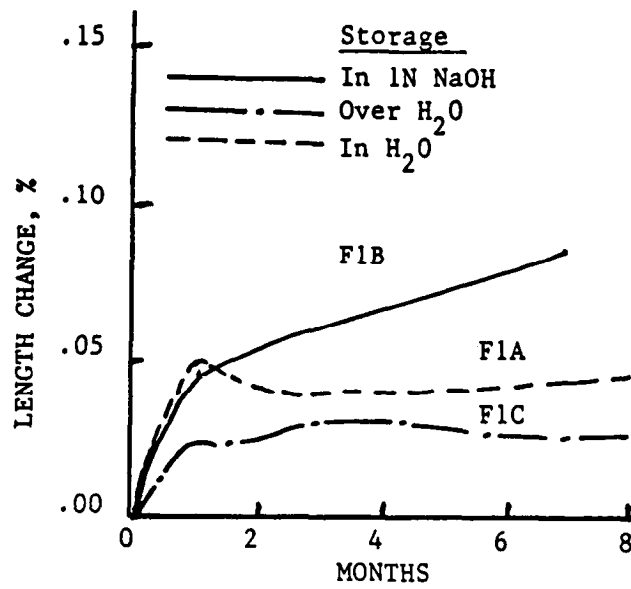
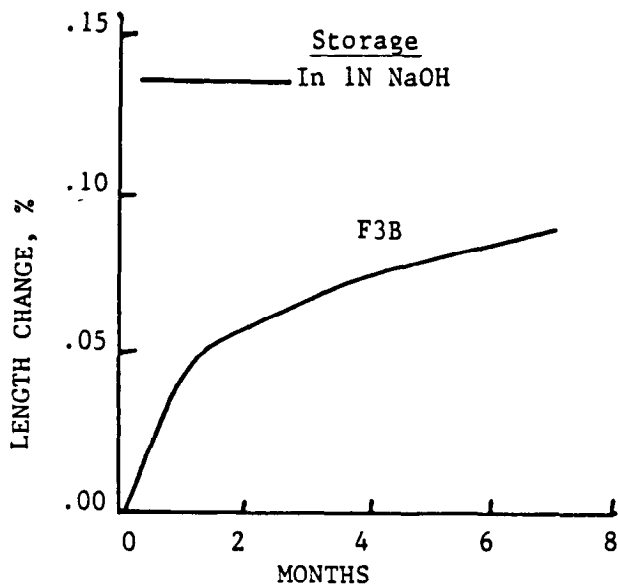
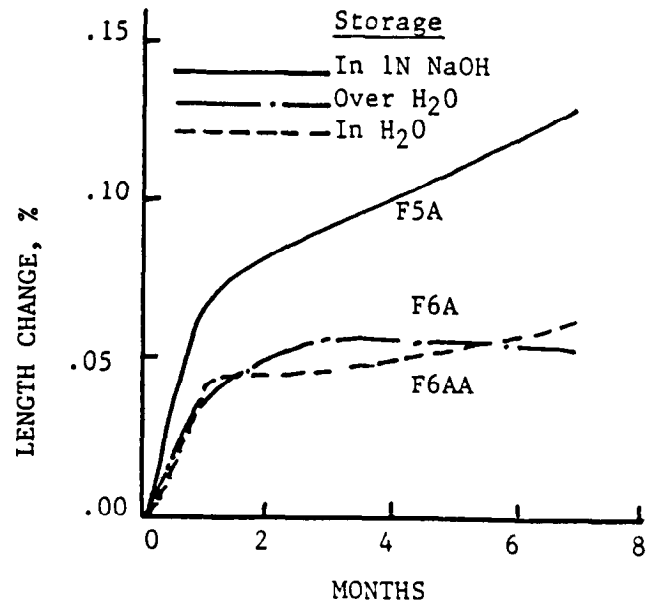
Figure A2. — Length change of cores stored under various conditions.

Core No.	Location	Depth (in)	Exposure	Percent length change at age indicated					
				1 mo.	2 mos.	3 mos.	4 mos.	6 mos.	7 mos.
F1A	North (end wall of adit at El. 1700. Block 34, 72 in. above floor. No cracking.	12 to 18	In H <sub>2</sub> O	0.050	0.040	0.038	0.040	0.046	0.048
F1B		21 to 27	In NaOH	.044	.050	.054	.068	.080	.088
F2A			Over H <sub>2</sub> O	.026	.026	.034	.034	.028	.028
F3B	East wall of adit at El. 1315, 9 ft upstream from lg. joint, 46 in. above floor. No cracking.	24 to 30	In NaOH	.048	.056	.064	.074	.084	.090
F5A	In roadway, top of dam, Block 35, 6 to 8 ft from sidewalk. Prominent map cracking.	24 to 30	In NaOH	.066	.082	.090	.096	.122	.132
F6A		23 to 29	In Na <sub>2</sub> O	.046	.048	.048	.054	.058	.064
F6AA		24 to 30	Over H <sub>2</sub> O	.042	.050	.058	.060	.056	.052

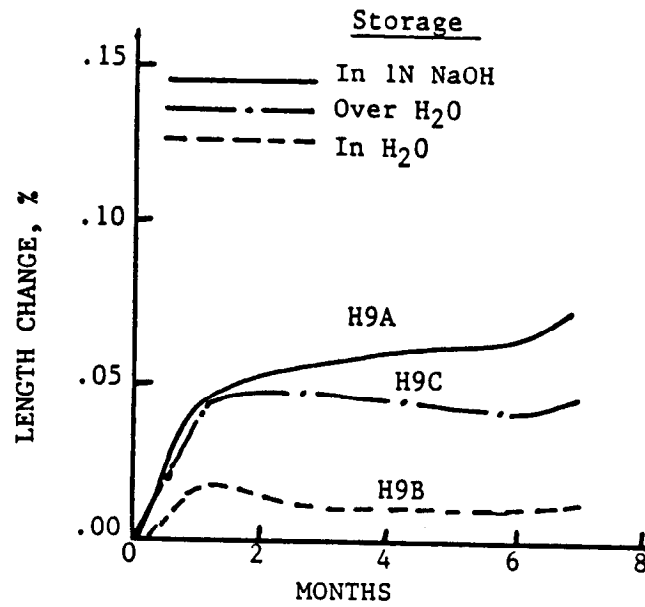
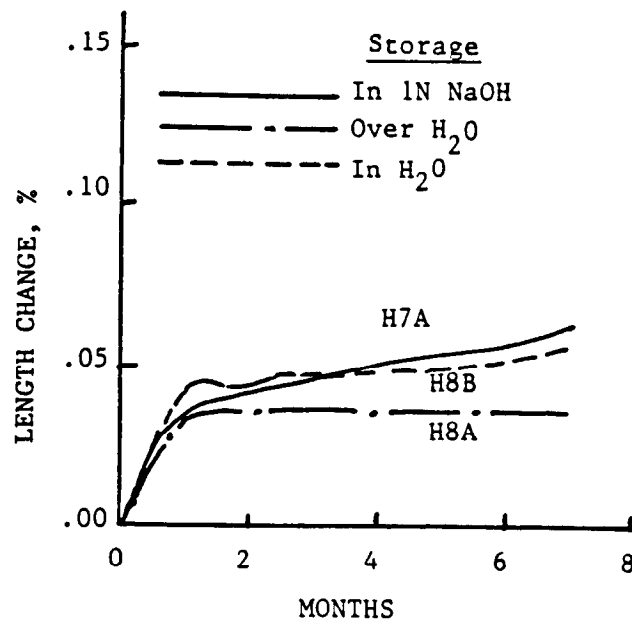
Figure B2. — Length change of cores stored under various conditions, Hiwassee Dam.

Core No.	Location	Depth (in)	Exposure	Percent length change at age indicated					
				1 mo.	2 mos.	3 mos.	4 mos.	6 mos.	7 mos.
H7A	Cores taken vertically into roadway at top of dam, Block 17, south-bound lane. Area displays large-scale map cracking.	24 to 30	In NaOH	0.040	0.044	0.046	0.052	0.056	0.062
H8A		15 to 21	Over H <sub>2</sub> O	.040	.036	.038	.038	.036	.034
H8B		21 to 27	In H <sub>2</sub> O	.048	.046	.052	.052	.052	.056
H9A	Core taken near outside door of adit at El. 1312, 4 ft above floor. Concrete displays faint map cracking.	17 to 23	In NaOH	.044	.052	.058	.060	.064	.076
H9B		18 to 24	In H <sub>2</sub> O	.018	.016	.010	.012	.010	.012
H9C		31 to 37	Over H <sub>2</sub> O	.048	.048	.048	.048	.040	.044

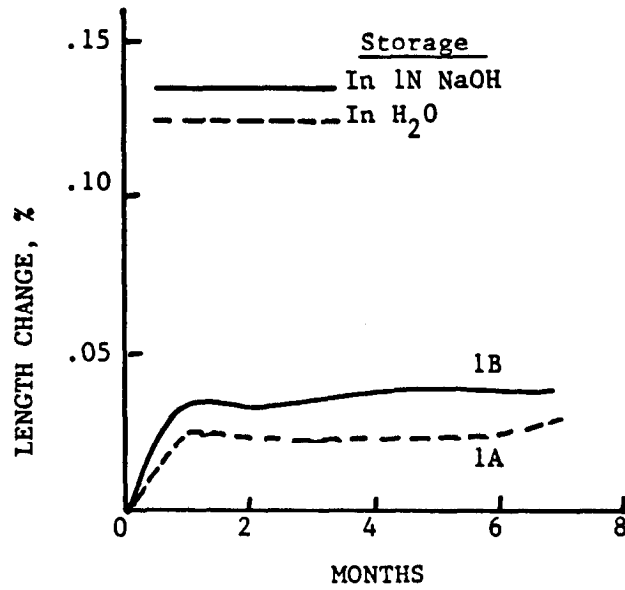
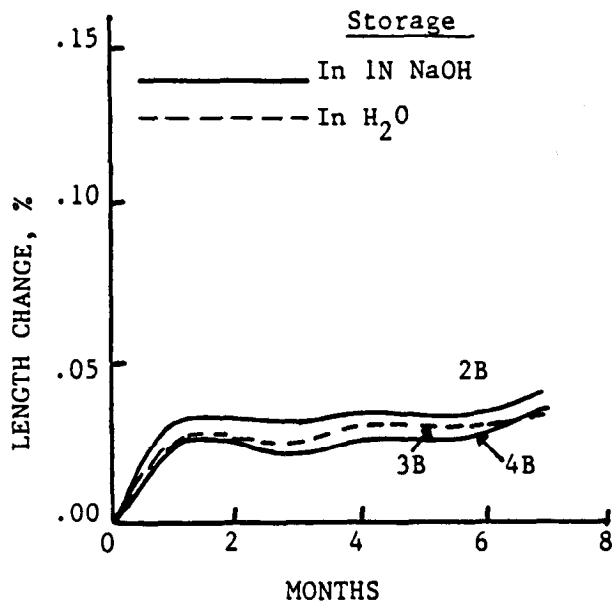
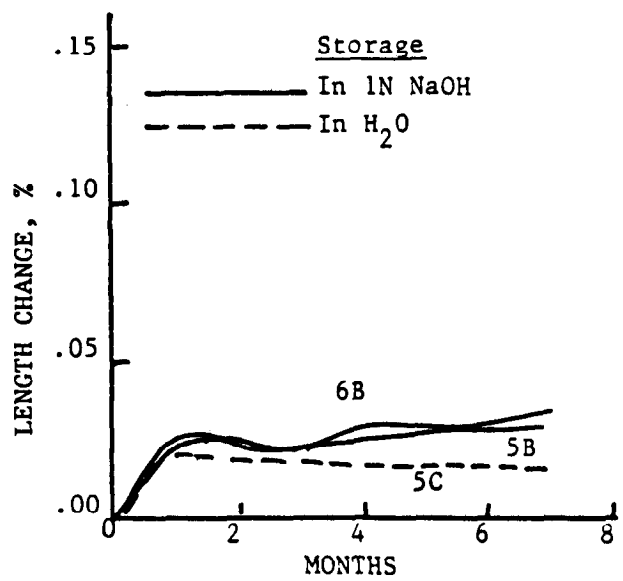
Figure C3. — Length change of cores stored under various conditions, New Savannah Bluff Lock and Dam.

Core No.	Location	Depth (in)	Exposure	Percent length change at age indicated					
				1 mo.	2 mos.	3 mos.	4 mos.	6 mos.	7 mos.
1A	Cores taken from top surface of lock wall on landside, 18 ft west of gate, 12 ft from face of wall.	5-11	In H <sub>2</sub> O	0.026	0.024	0.014	0.024	0.024	0.030
1B		13-19	In NaOH	.046	.032	.026	.038	.038	.038
2B	Cores taken from south face of abutment, South Carolina side, 2 ft and 8 ft from upstream face 3 to 4 ft up from floor.	12-18	In NaOH	.032	.036	.032	.038	.034	.042
3B		12-18	In H <sub>2</sub> O	.028	.030	.016	.032	.032	.036
4B	Cores taken from south face of south abutment wall, 15 ft from top of wall, 20 ft downstream from abutment.	12-18	In NaOH	.030	.024	.022	.028	.028	.038
5B	Cores taken from top surface	12-18	In NaOH	.030	.024	.024	.028	.030	.030
5C	of first pier from lockmaster's	12-18	In H <sub>2</sub> O	.022	.020	.020	.018	.018	.014
6B	house, 4 ft from faces of pier.	5-11	Over H <sub>2</sub> O	.028	.026	.014	.032	.032	.036
